CASE STUDY: Trevenson Gateway – JSL (Trevenson) Limited (2017-19)

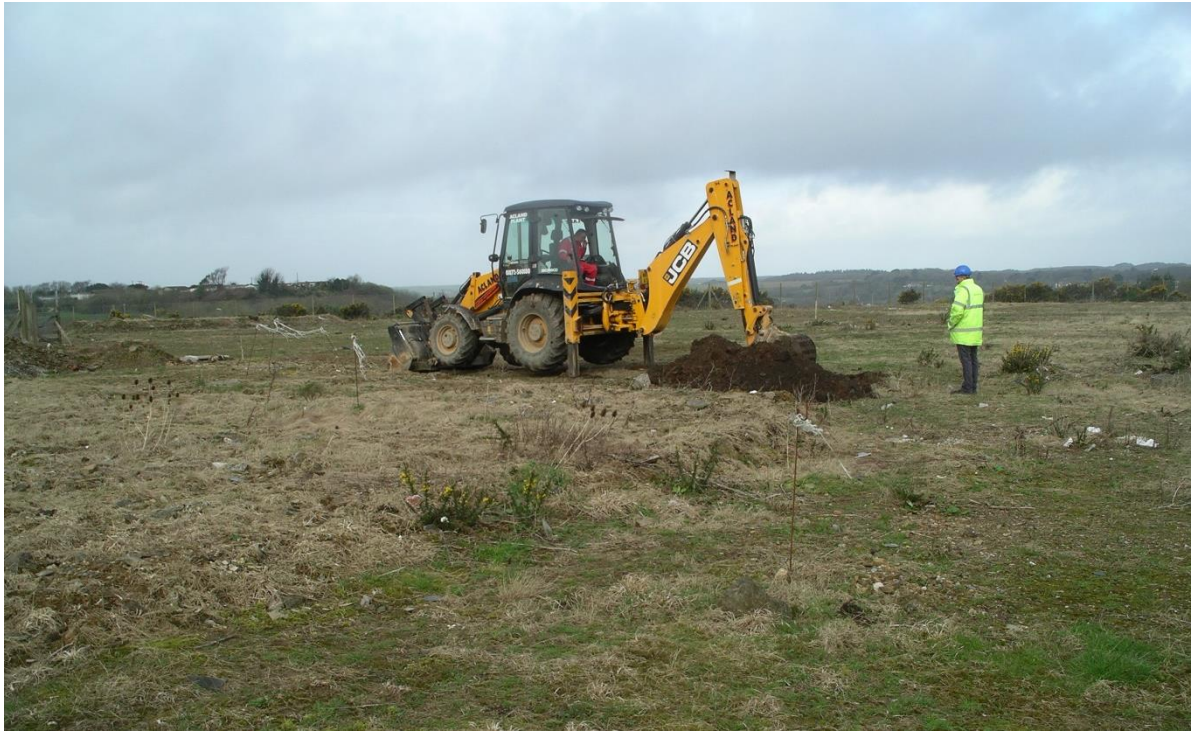
March 2017: Trial hole investigation in progress.

We conducted a site investigation in March 2017, involving the creation of over 30 test holes. This investigation confirmed that the Japanese knotweed on site had not been eradicated, but had rather been spread by the previous works due to fragmentation of the rhizomes and crown material, followed by soil movement across the site. This meant the knotweed locations had been multiplied and could be found at depth – possibly deeper than 5 metres. The onsite investigation also revealed that the made up ground was extremely soft in much of the site and had a low bearing capacity.

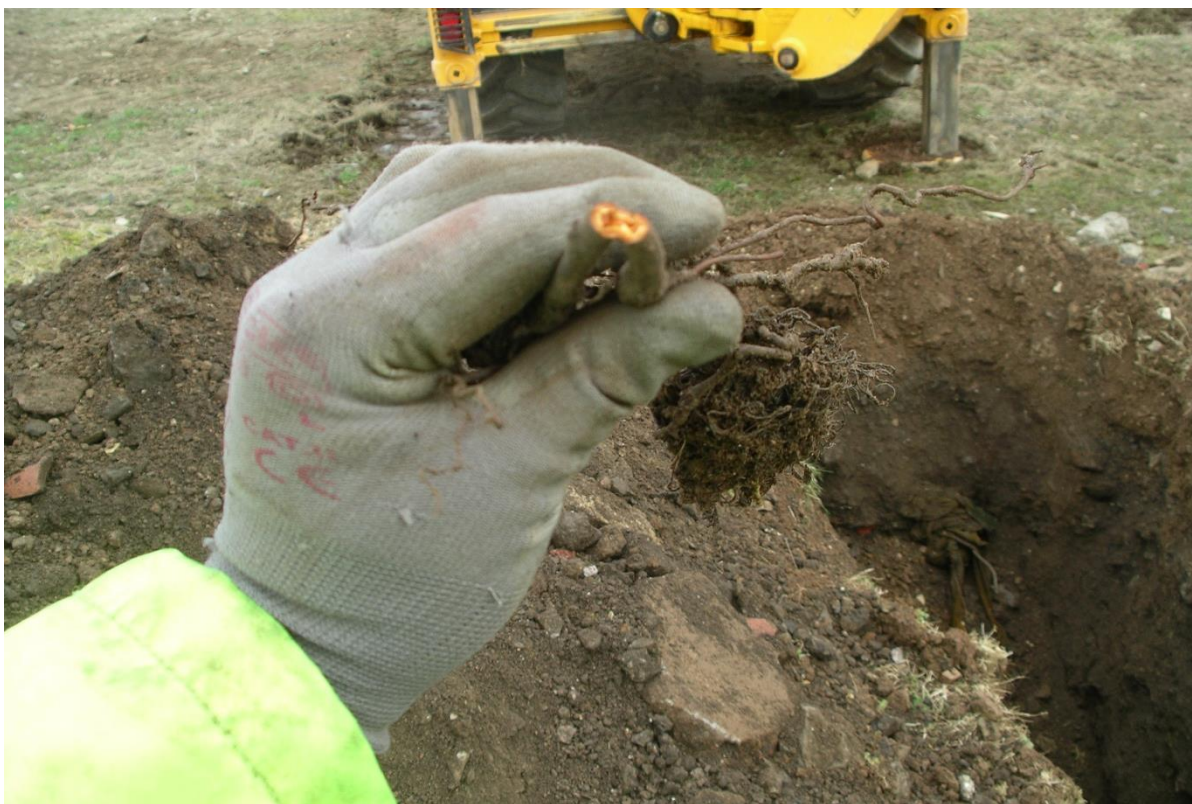
March 2017: Viable Japanese knotweed fragments identified. Fragment recovered from 2.6 m depth.

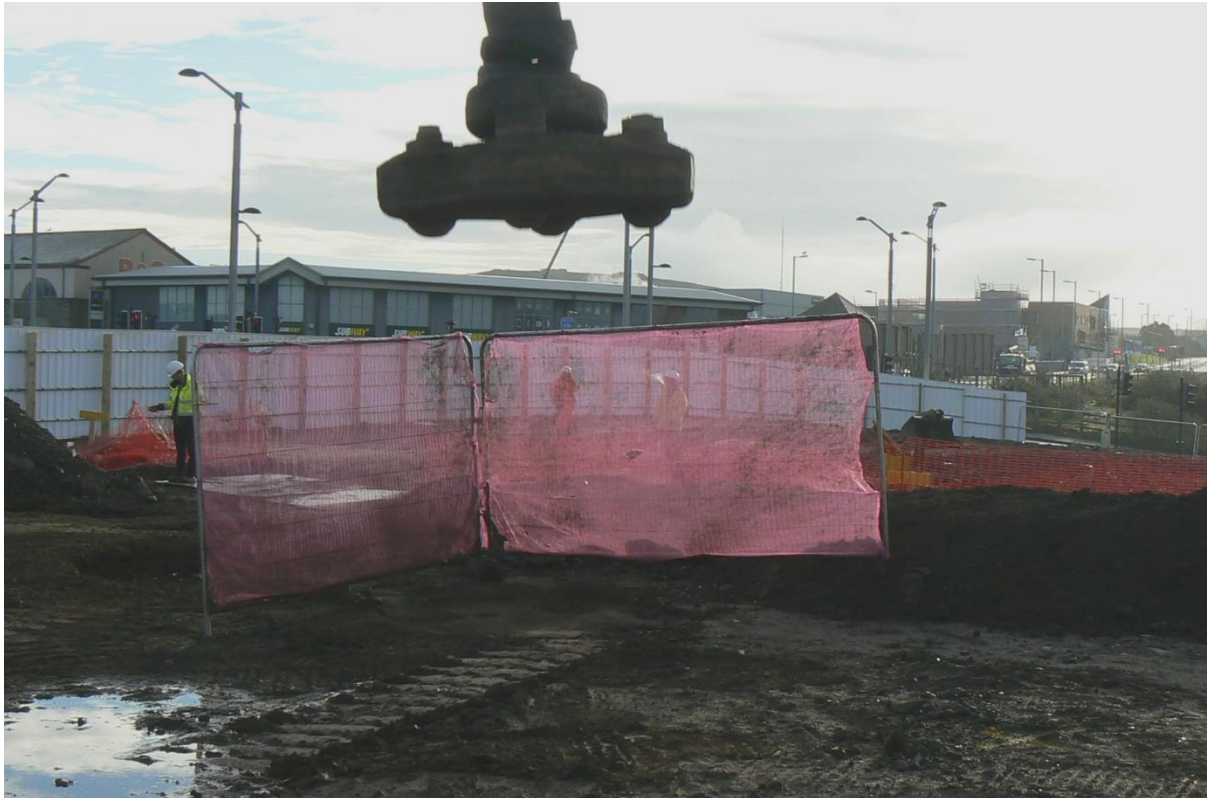
Nov/Dec 2017: Dynamic compaction on site.

Ground consolidation (in this instance) involves compacting the soil by repeatedly dropping a heavy, specially-shaped concrete weight, according to a specially designed plan, by use of a crane. The consolidation continues until the agreed weight-bearing capacity has been achieved. Ground consolidation is a little-used technique in the UK (it is mainly used in France for brownfield sites), but it created a number of advantages for this site. These included:

By April 2018, the site consolidation had taken place. This was conducted by a French company. It reduced the site level and compacted the ground to the required levels to such an extent that piling and geogrids are no longer considered to be necessary. Extensive amounts of root barrier are being used on site to protect all the buildings and hard surfaces. The site is also to be subject to an extensive monitoring and herbicide treatment programme.

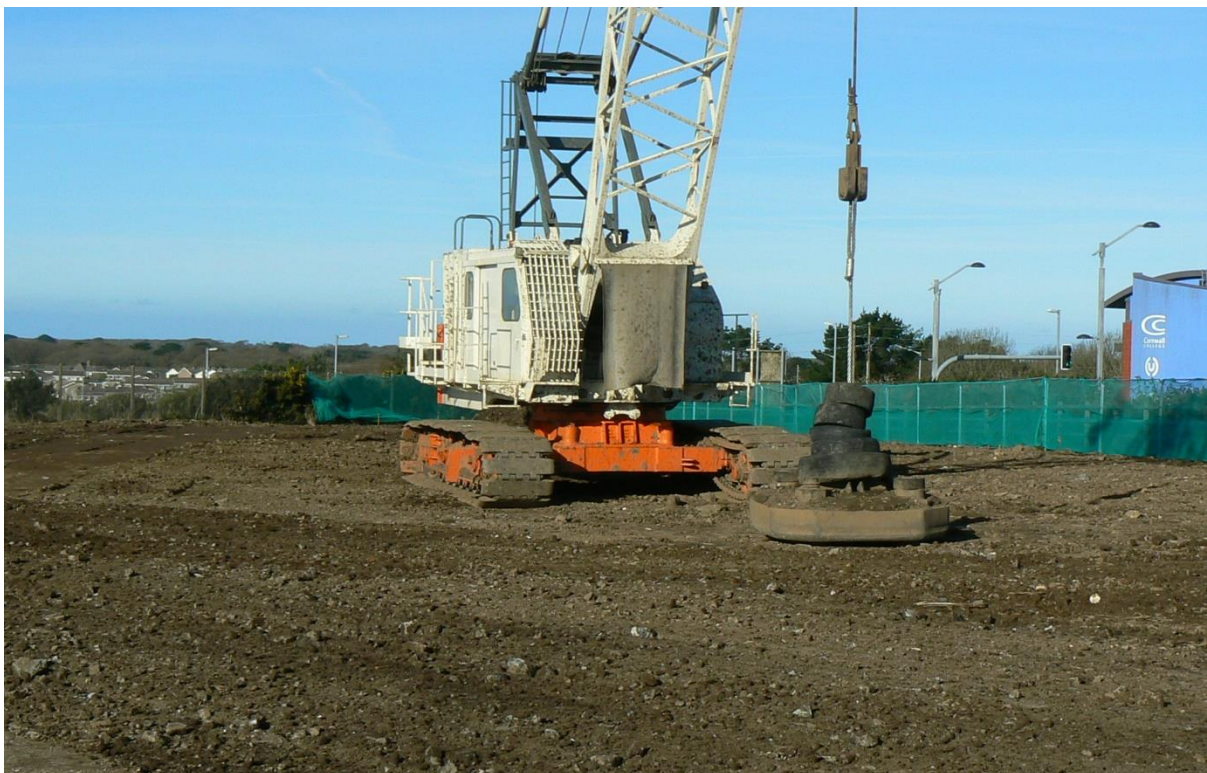
Nov/Dec 2017: Compaction equipment when lowered.

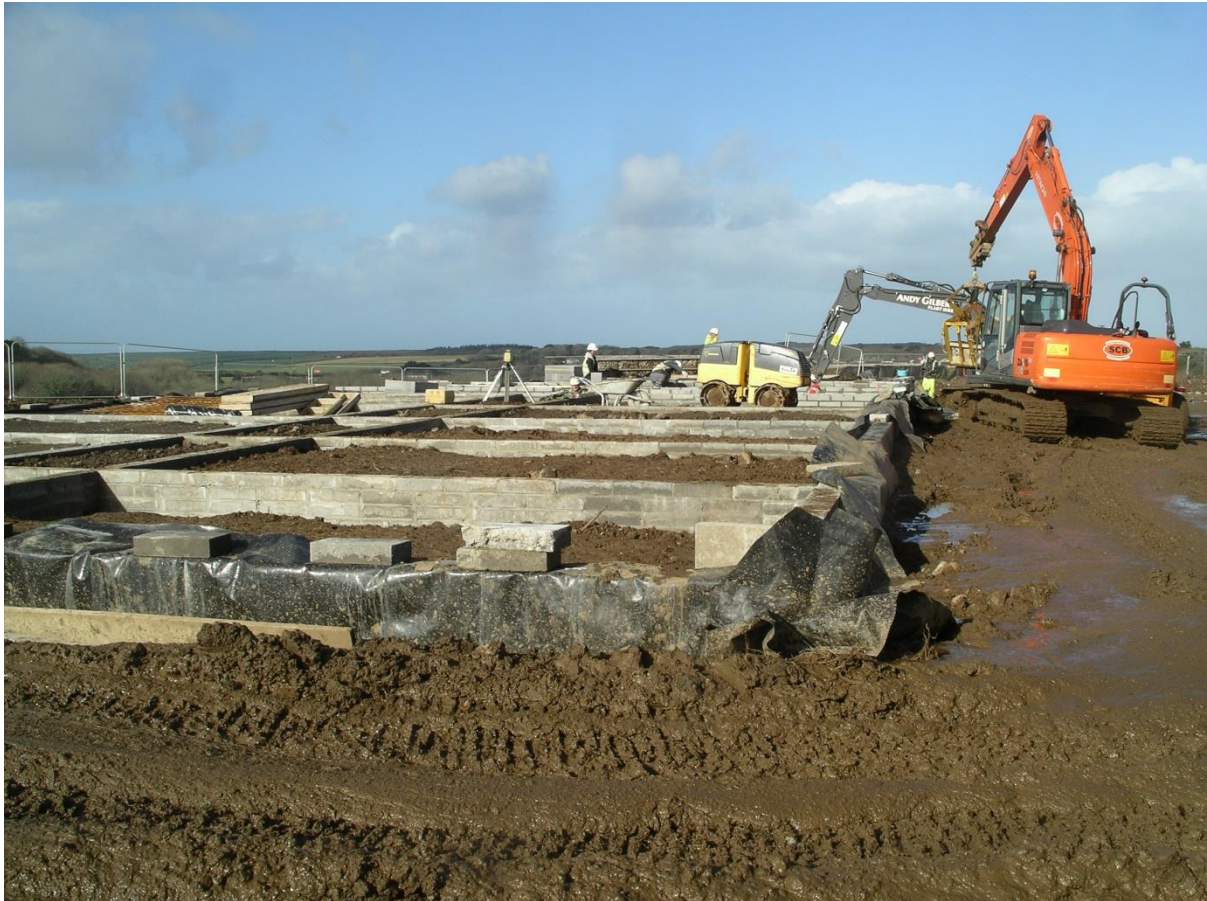
January 2018: Japanese knotweed barrier fitted under foundation.

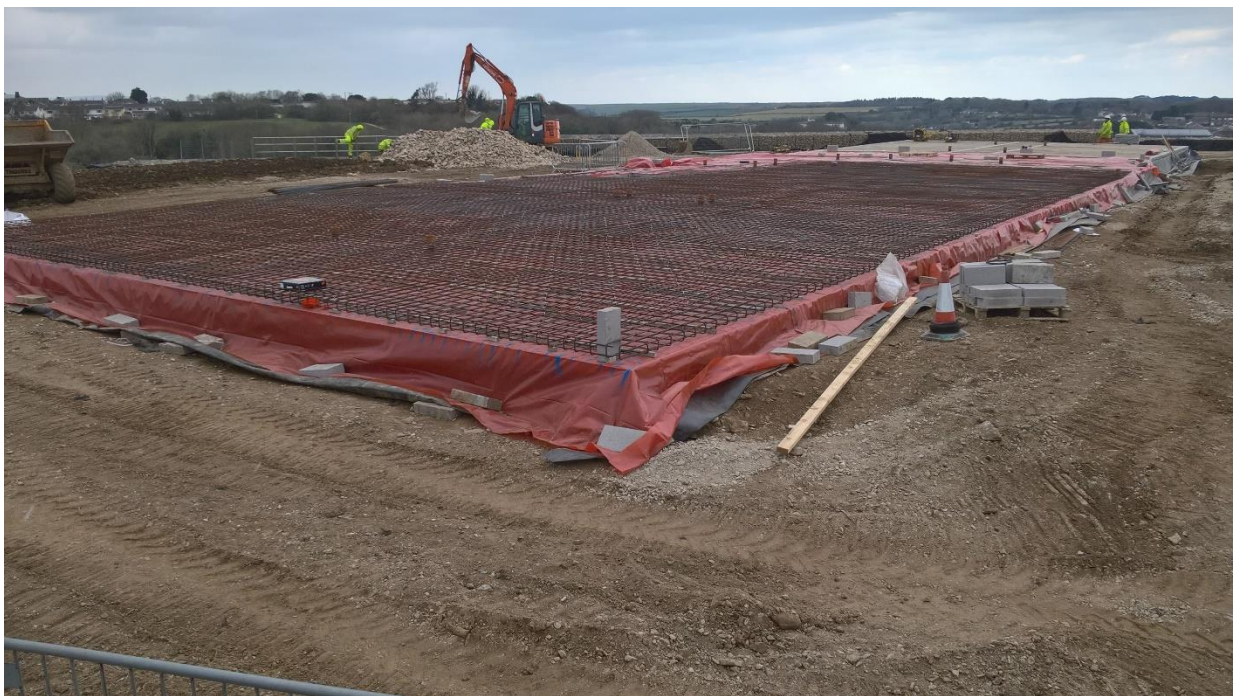
February 2018: Works in progress for new Travelodge. Note radon barrier (red) and Japanese knotweed root barrier (black).
